Case Vehicle (A): 1998 Mercury  
 Type: Tracer, 4-door coupe  
 Driver: 20-year-old female  
 CDC: 02-RYEW-3

Vehicle (B): 1995 Mercury  
 Type: Sable, 4-door sedan  
 Driver: 53-year-old male  
 CDC: 99-0000-0

## SITUATION

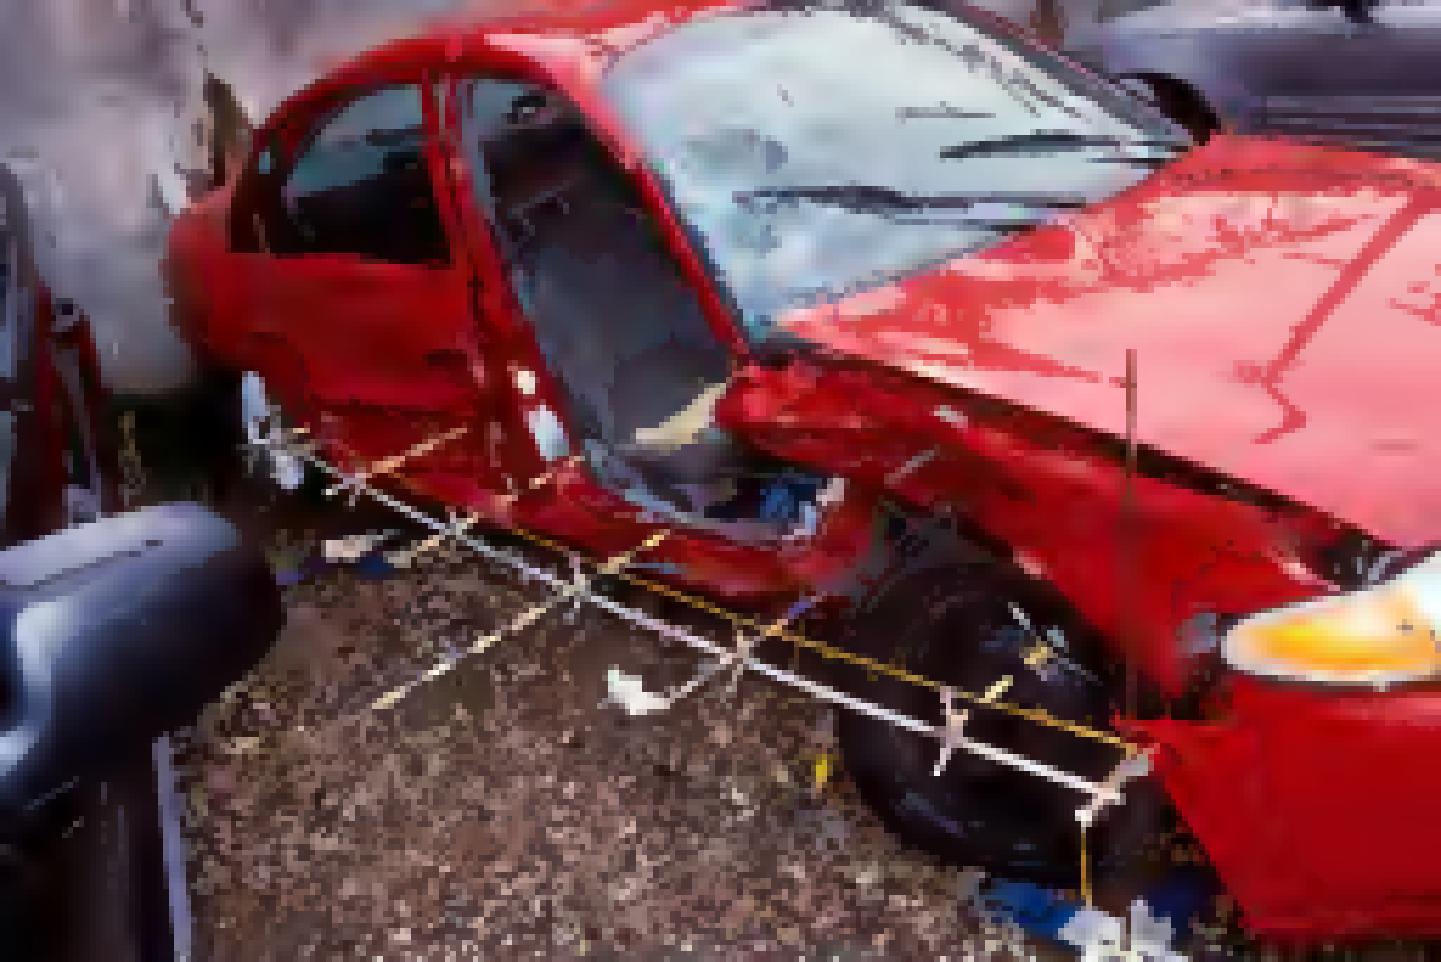
PN 21900 #5

(Slide 4) Damage to the right-front fender and right-front door of case vehicle (A) was severe. The direct-damage length was 207 cm above the sill, and began just forward of the right C-pillar and ended just behind the right-front axle. The maximum crush was 42 cm and occurred forward of the lower A-pillar. The right wheelbase was reduced 4 cm, and the left wheelbase was extended 13 cm.

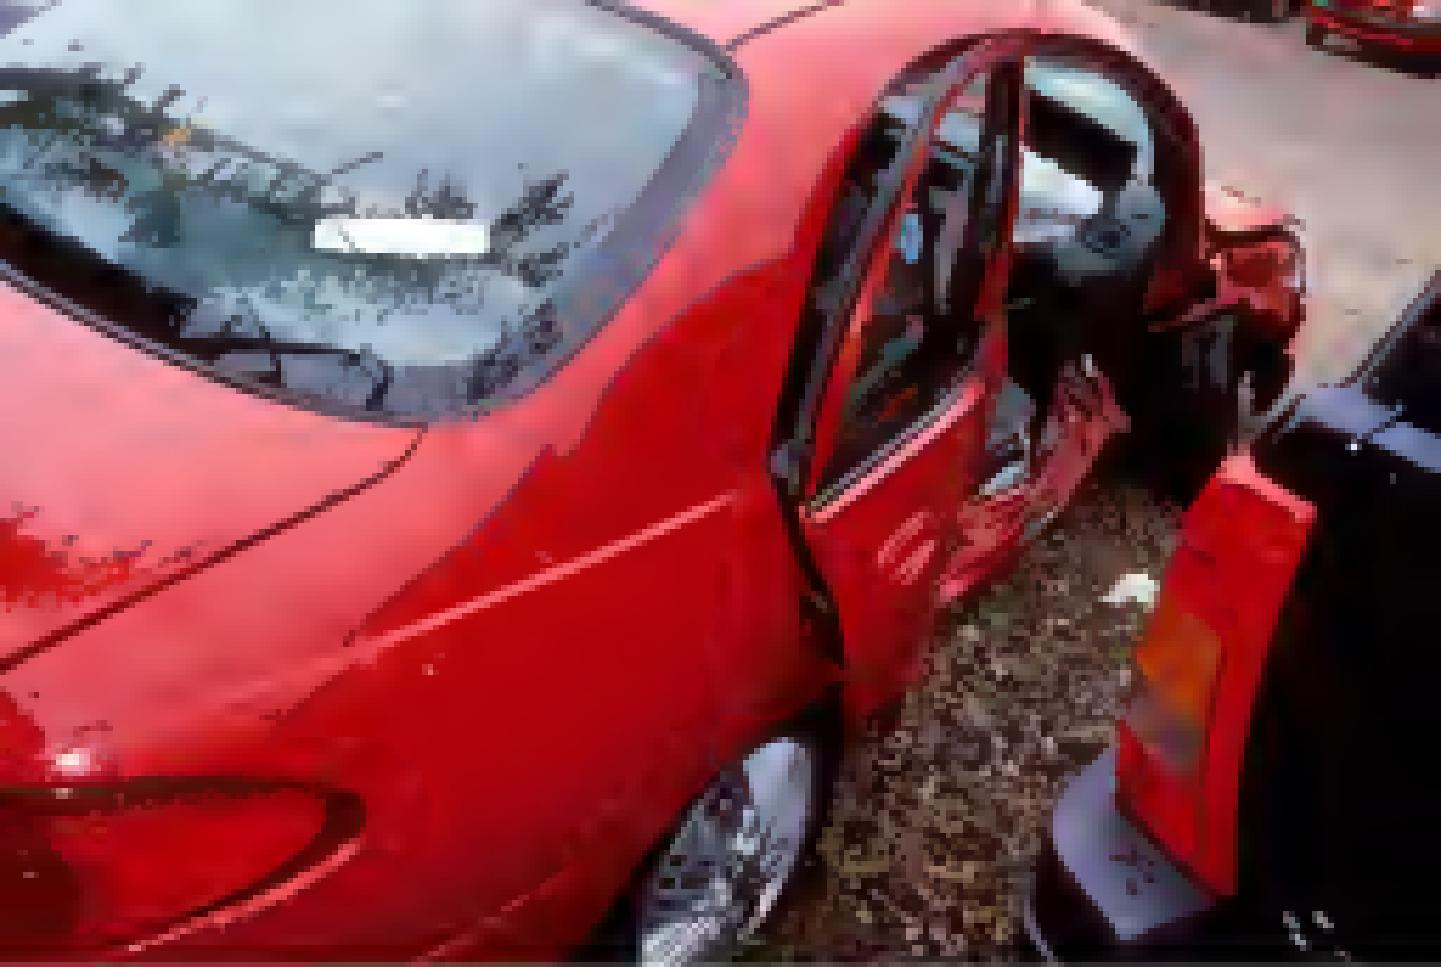
PN 21900 #9

(Slides 8, 9, 10, 11, 12, 13) The right fender, the right-front wheel strut, the right A-pillar, the right door, and the right B-pillar were crushed. The windshield was damaged by impact forces.

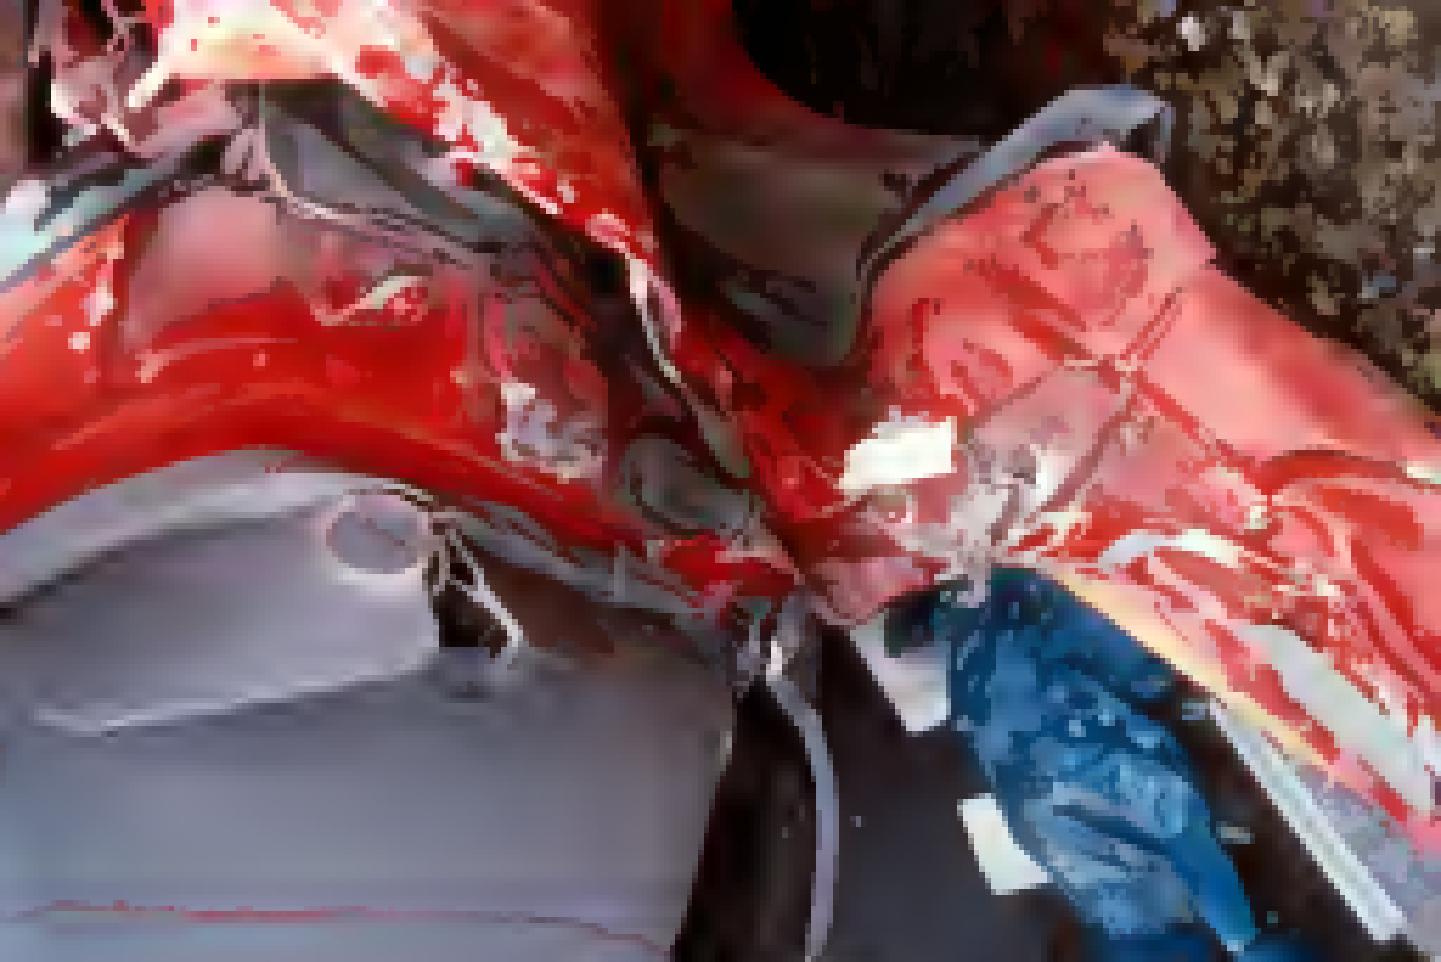
PN 21900 #13

Both right-side doors were jammed closed. (Slides 14, 15) The right-front door was removed from the vehicle during extrication of the right-front passenger. The hood latch was damaged, but remained operational. The right hood hinge was slightly deformed, but not separated. The right rear edge of the hood was elevated, but it did not contact the damaged windshield.

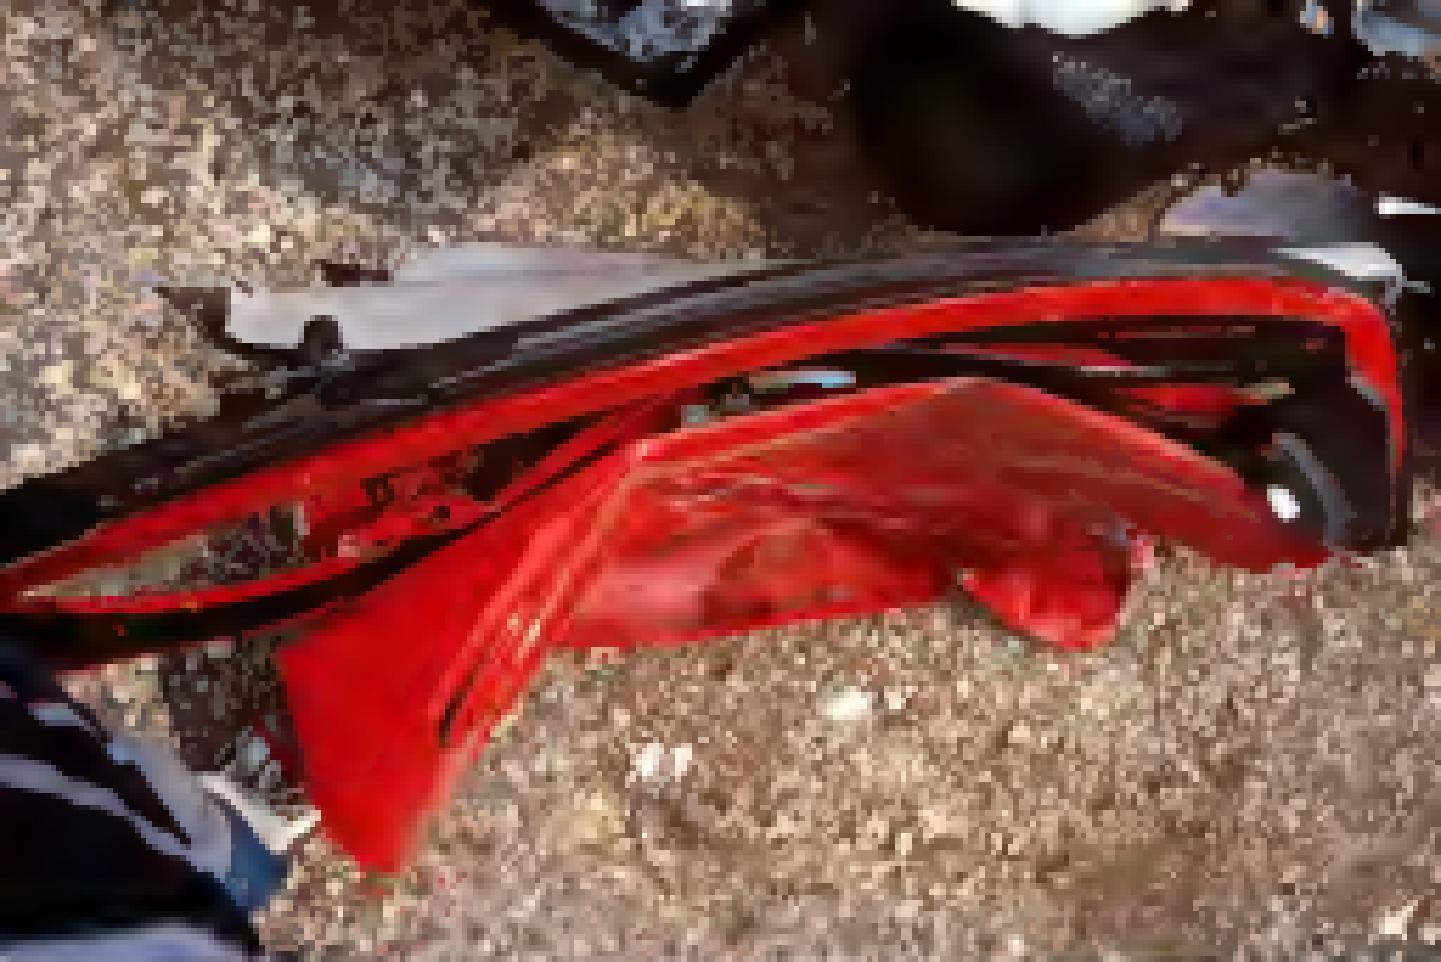
PN 21900 #15

(Slides 16, 17, 18, 19) This vehicle was equipped with both steering-wheel and passenger frontal-impact airbags, which deployed during the right-side impact. (Slides 20, 21, 22) No damage was noted to the airbag skins or module doors/flaps. (Slide 23) The steering-wheel rim was not deformed, and the steering-wheel column was not rotated. (Slides 24, 25, 26, 27, 28, 29, 30, 31) The right-front door, the armrest, the glove box door and the right kick panel were damaged by intrusion and occupant contact. The right-front door hardware, the right kickpanel, the glass, the roof siderail, and the right A- and B-pillars were damaged by intruding structural components. The windshield was cracked due to right A-pillar movement and from contact by the deploying passenger frontal-impact airbag door/flap. The rearview mirror was dislodged from its mount. The upper, mid and lower instrument panels, the climate control vents, and the parking brake lever were damaged by intruding structural components. The right-front seat adjuster was deformed and jammed and the backrest and cushion were damaged by the intruding door. (Slides 32, 33, 34, 35, 36, 37) The following intrusions were noted and measured:
